# HORN SYSTEMS

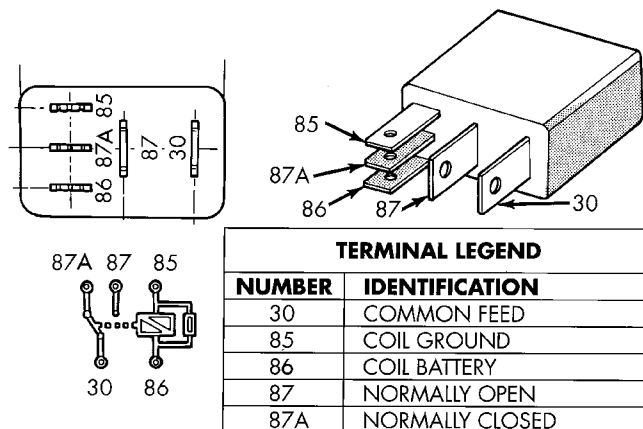
9514-16

**Fig 1. Horn Relay****DIAGNOSIS AND TESTING****HORN RELAY**

The horn relay (Fig. 1) is located in the Power Distribution Center (PDC) in the engine compartment. Refer to the PDC label for horn relay identification and location.

no continuity between terminals 87 and 30. If OK, go to Step 2. If not OK, replace the faulty relay.

(2) Resistance between terminals 85 and 86 (electromagnet) should be  $75 \pm 5$  ohms. If OK, go to Step 3. If not OK, replace the faulty relay.

(3) Connect a battery to terminals 85 and 86. There should now be continuity between terminals 30 and 87, and no continuity between terminals 87A and 30. If OK, see the Relay Circuit Test in this group. If not OK, replace the faulty relay.

(1) A relay in the de-energized position should have continuity between terminals 87A and 30, and

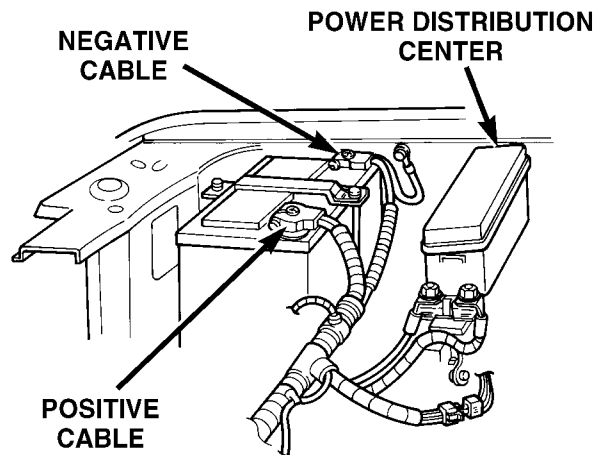
80a7233a

(2) Remove the cover from the Power Distribution Center (PDC) (Fig. 2).

**Fig. 2 Power Distribution Center**

(3) Refer to the label on the PDC for horn relay identification and location.

(4) Unplug the horn relay from the PDC.

(5) Install the horn relay by aligning the relay terminals with the cavities in the PDC and pushing the relay firmly into place.

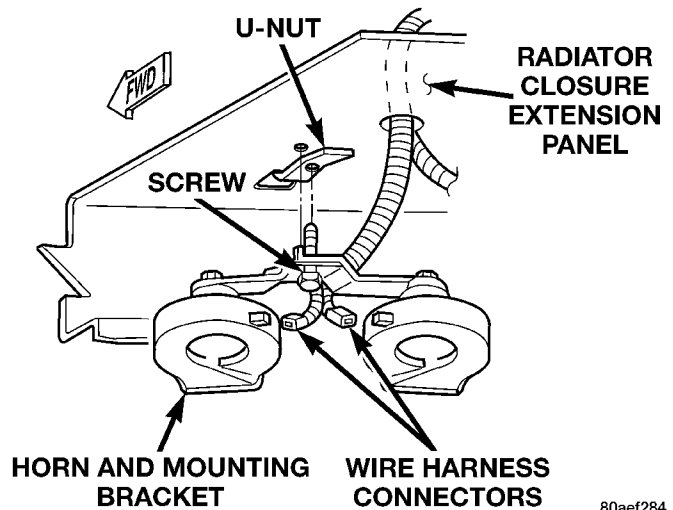
80aef284

- (1) Disconnect and isolate the battery negative cable.
- (2) Raise and support the vehicle.
- (3) Remove the radiator lower air deflector. Refer to Group 7 - Cooling System for the procedures.
- (4) Unplug the wire harness connectors from the horns (Fig. 3).
- (5) Remove the screw that secures the horn mounting bracket to the radiator closure extension panel.

**Fig. 3 Horns Remove/Install**

- (6) Remove the horns and mounting bracket from the vehicle.
- (7) Reverse the removal procedures to install. Tighten the horn mounting bracket screw to 28 N·m (250 in. lbs.).
